Report on Measurement of Lean Angle for Perimeter Fencing of Woods of Wimbledon  
Don W. Shackelford  
Professional Engineer; Oklahoma 111405  
Nov 25, 2015

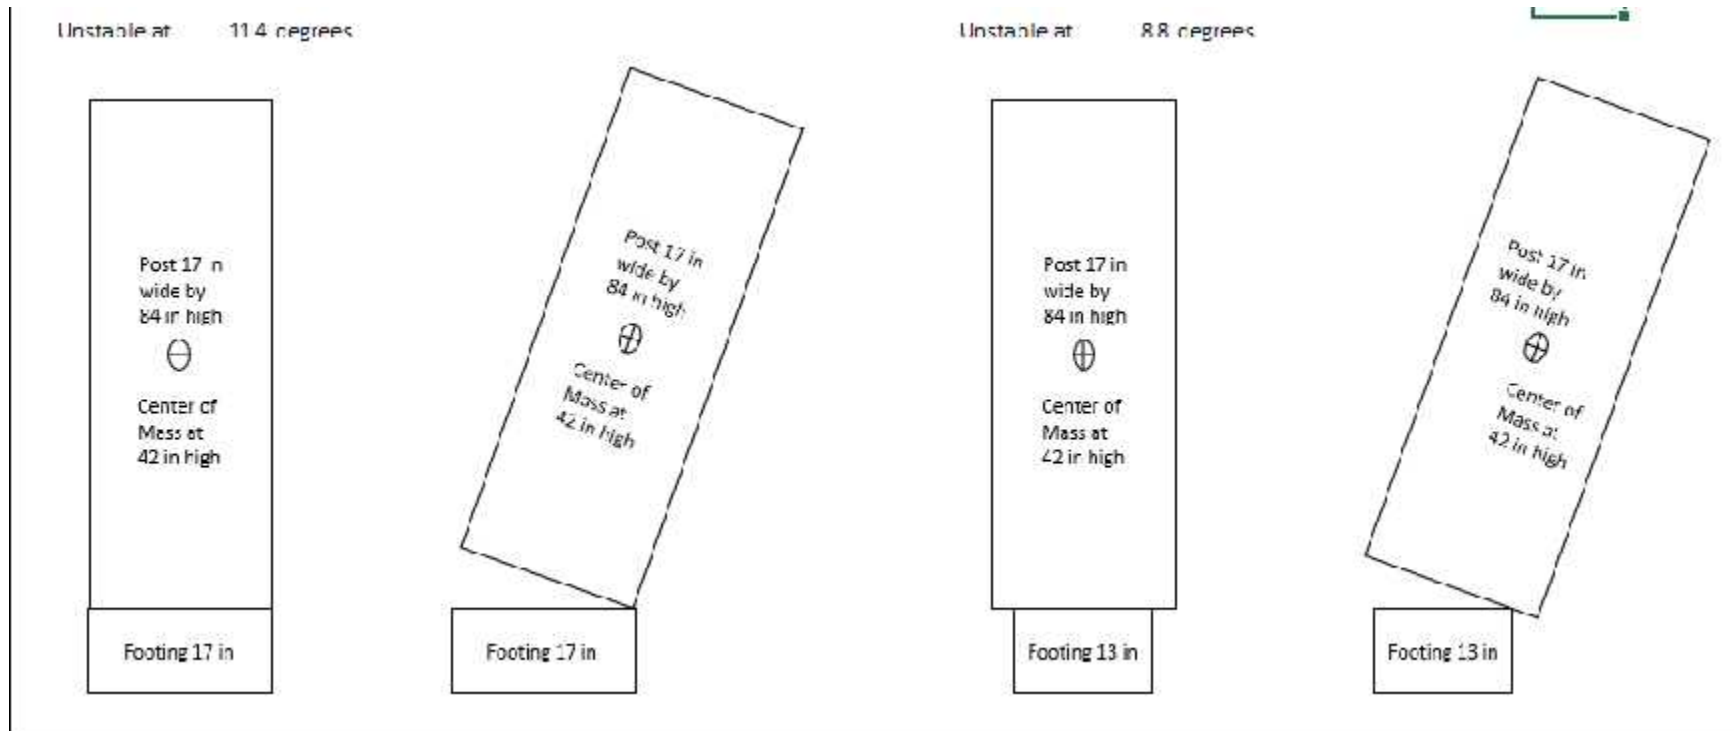
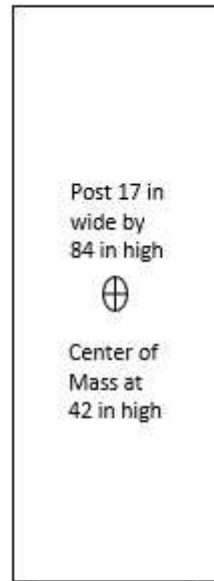
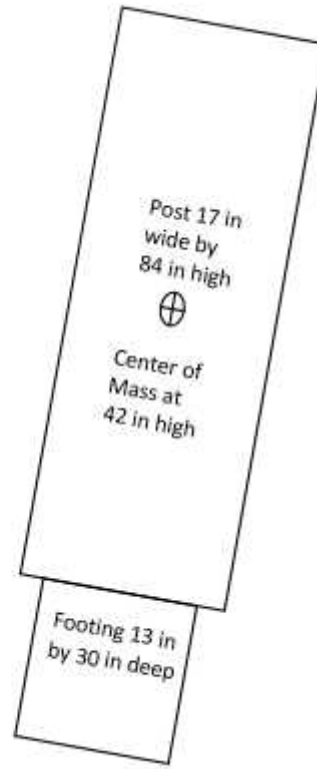
Fig 2 Illustration of 3 Types of Footing Support and the Angle Calculated for Instability

Post lean angle was examined for instability based on 3 different types of subsurface support by the footing. Instability is defined for this report as the angle where the weight of the posts tends to increase the lean angle. In the worst case examined an angle of 5.2 degrees would become unstable. The impact of this would be that the posts would likely continue to fail even if the initial cause of the post lean was removed.

Discussion: Once the data had been collected stability calculations were made. Three types of support were considered as shown in Fig 2. The first condition examined footing support over the entire cross section of the fence post and that the post was leaning but the footing remained in its original position. The second condition examined footing support over the post that was 2 inches inside over the entire post cross section perimeter as was measured when the lean angle data was collected. The post was leaning in this second condition but the footing remained in its original position. The third condition examined this reduced footing support but pivoting with the post at a footing depth of 30 inches. If the weight of the footing was considered in case 3 it would lower the center of mass distance. The center of mass was not changed for calculating instability angle for condition 3 as the actual construction of the footing is not known nor is the material used for the footing known. For the footing to be moving with the post it is likely the footing may have failed and these failure cracks or breaks in the footing may be numerous which would result in a smaller footing size moving with the post.

Unstable at 5.2 degrees

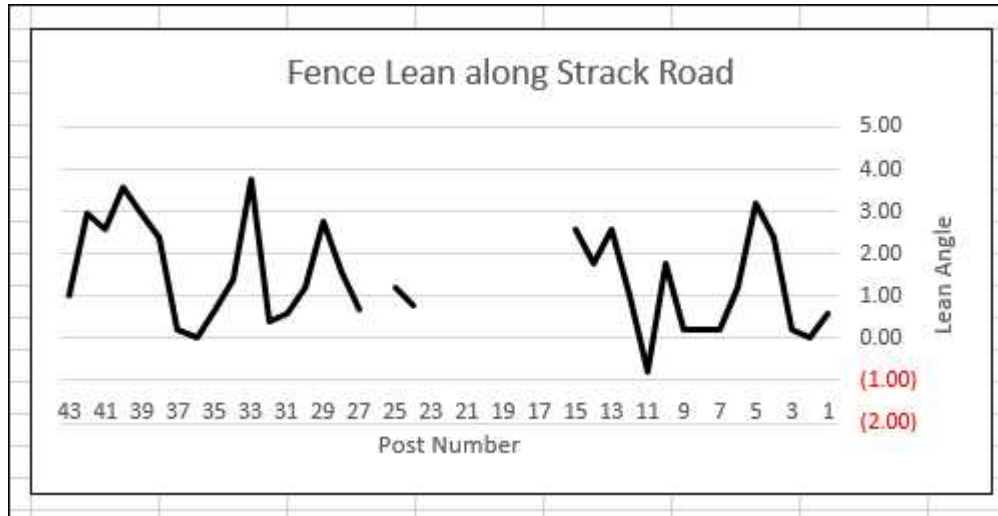
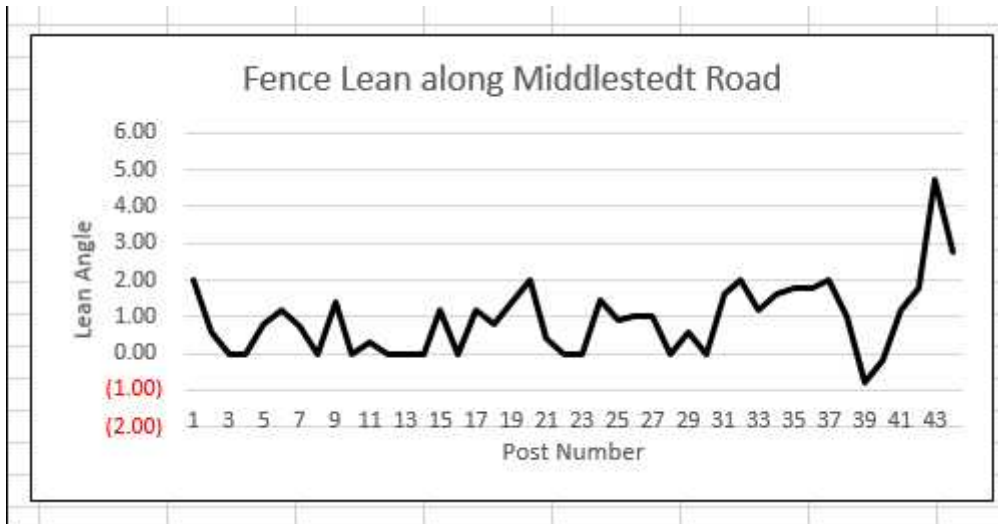
Fig 3 Plots of Fence Lean as Measured along Strack Road and Middlestedt Road

Executive Summary: Perimeter fencing of the Woods of Wimbledon residential development in Houston, Texas was measured for lean angle. There are two fences, one along Strack Road and one along Middlestedt Road. There are a total of 44 support posts on each of the two fences for a total of 88. A total of 78 posts were measured for lean angle. Ten posts were covered with vines or otherwise obstructed and were not measured. Out of the 78 posts which were measured, 61 had some lean angle outward with 3 having some angle inward. There were 37 posts with greater than 1 degree of lean angle, 13 posts with more than 2 degrees of lean angle, 4 posts with more than 3 degrees of lean angle, and 1 with more than 4 degrees. This last post measured about 4.8 degrees of outward lean and is in the worst shape of all posts examined.

Plots were made of the fence lean angle which are not to scale but are intended to represent the general top view of the fence as it exists. These plots are shown in Fig 3.
